GROOPS DAM

PHASE I INSPECTION REPORT NATIONAL DAM INSPECTION PROGRAM

CROOPS DAM, NDS I.D. No. PA 01063

PHASE I INSPECTION REPORT
NATIONAL DAM INSPECTION PROGRAM
CROOPS DAM
NATIONAL ID NO. PA 01063
DER NO. 40-227

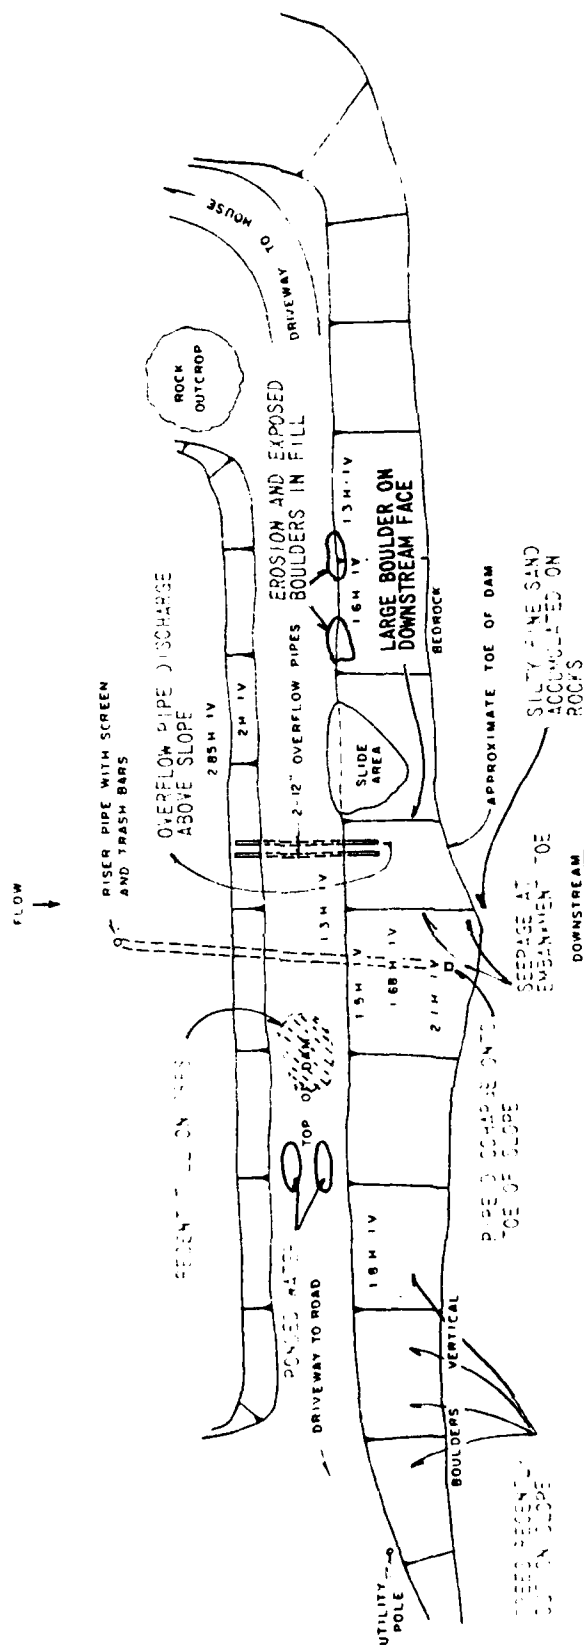
Sheet 5 of 11

<u>VISUAL EXAMINATION OF</u>	<u>OBSERVATIONS</u>	<u>REMARKS OR RECOMMENDATIONS</u>
Vegetation	Embankment slopes are covered with grass and vegetation including briars, ferns, weeds, and trees. Trees on upstream slope have been cut. Trees on downstream slope are being cut.	
JUNCTION OF EMBANKMENT AND ABUTMENT, SPILLWAY AND DAM	All abutment and embankment junctions are in good condition with no gullying observed.	
ANY NOTICEABLE SEEPAGE	Yes, volume of seepage is estimated to be greater than discharge through spillway. See Sheet 5A of 11.	
STAFF GAGE AND RECORDER	None.	
DRAINS	None located.

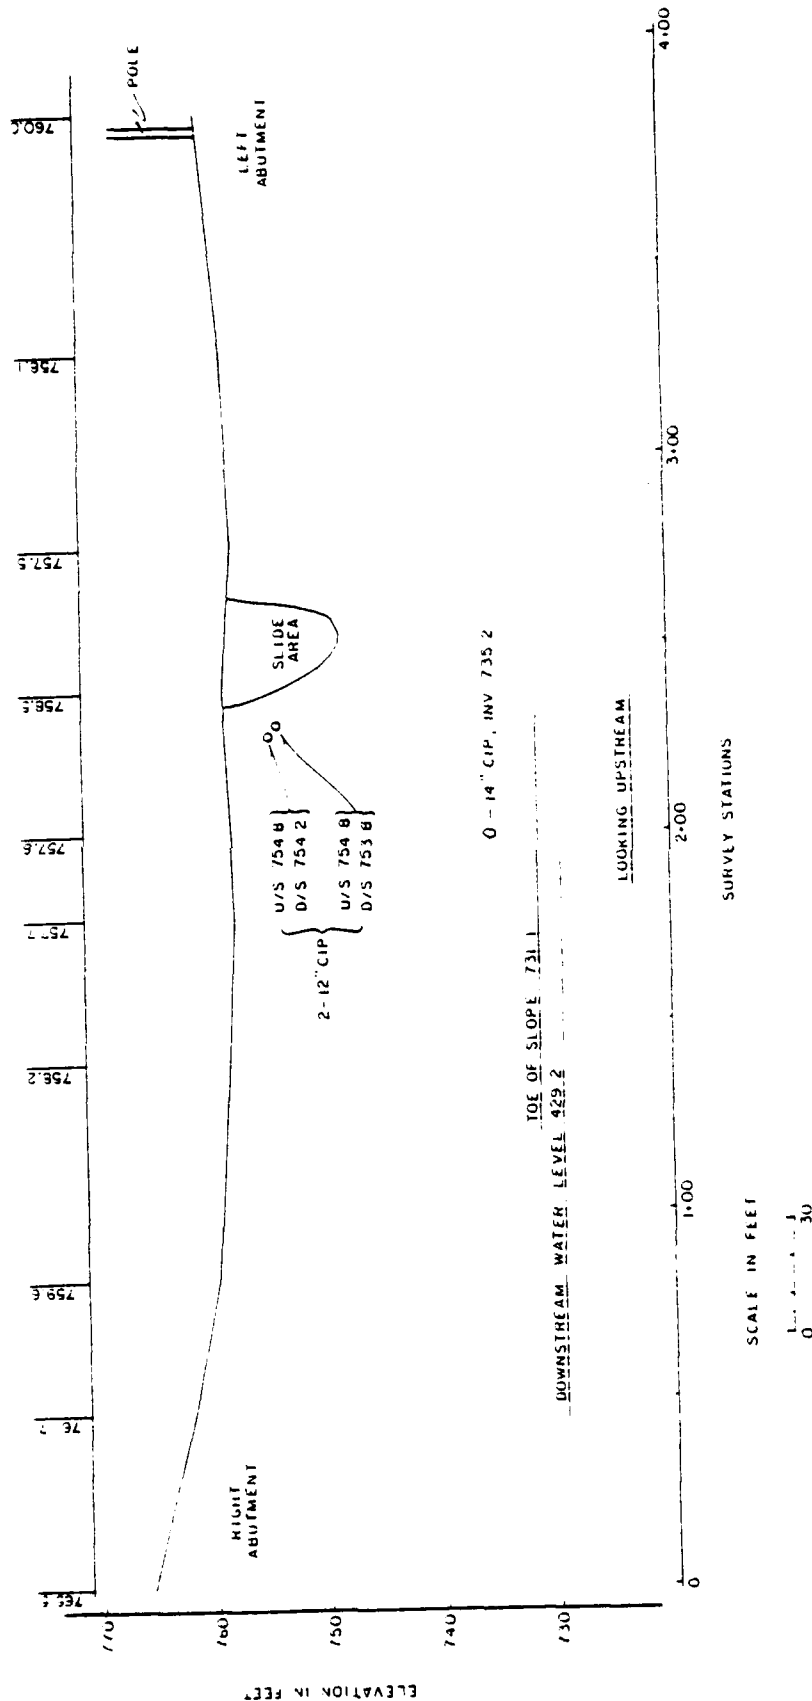
PLATE 3

b. Dam. The vertical alignment of the dam crest was checked and, as shown on Plate 3, Appendix E, crest elevations range from 757.6 to 759.6. A private road crosses the crest, and the elevation of the crest increases toward each end, allowing surface runoff to flow along vehicle tracks, ponding at the embankment low points. Small channels were recently dug to the upstream and downstream faces of the dam to drain the ponded area, and fill was placed in the depressions. At another location on the dam crest (Photograph 6), water was ponded from recent rainstorms.

PROFILE OF DAM
CROOPS DAM
